# CanSat 2023

## Post Flight Review (PFR)

**1070**  
**Obsidian**

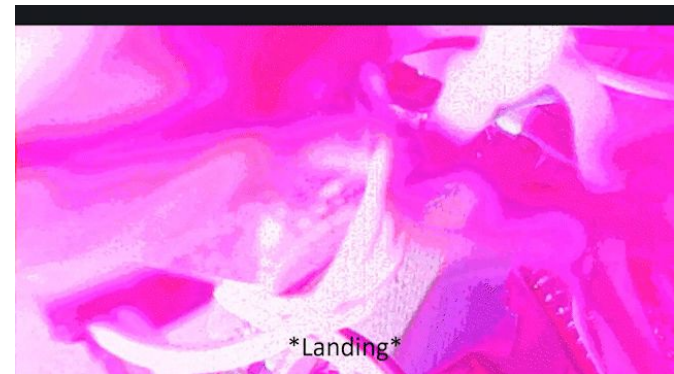
## Main Failure

After researching into the graphs and physical data, we discovered that our CanSat failed its landing phase because of power surges. During our ascent and landing phases, arcs were observed crossing through the carbon fiber rods into the PCB, which caused a black-out. The only exception was the camera itself, as it was connected to a carbon fiber rod that was grounded to the power system. This caused the camera to continue working while the rest of the electronics were non-functional.

In the future, we will be more careful and do more research into the materials that we use along with their properties, as this can become a critical failure point later on.
