CanSat 2023

Post Flight Review (PFR)

Team 1079
Team Afterburner

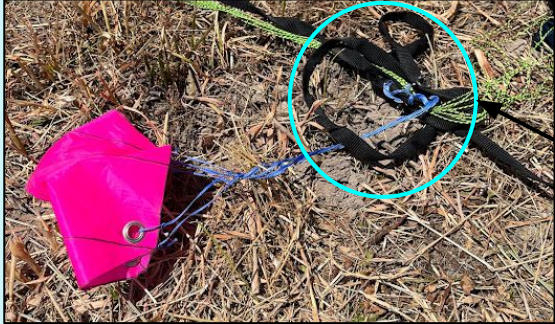
Major Launch Events		Images
1	Container parachute was tangled in the rocket shock cord and separated from the container

<p>Tangled Line</p>
2	Container ripped away from tangled container parachute. The probe and container fell together upside down, with the probe ejection hole facing upwards

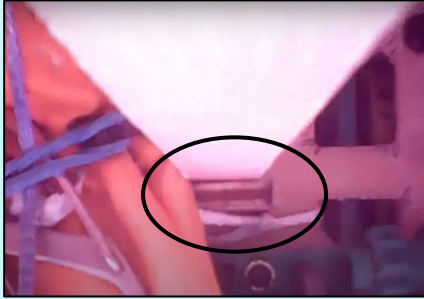
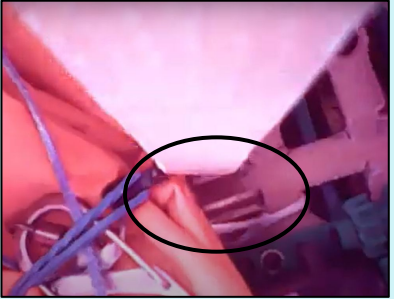
Major Launch Events		Images																																																																												
3	<p>Probe release mechanism actuated, but due to the orientation of the payload and the lack of the container parachute, it did not separate from the container</p>	<p>Before Separation</p>

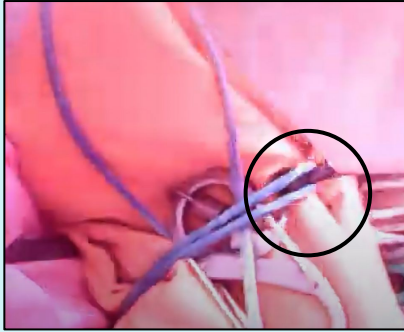
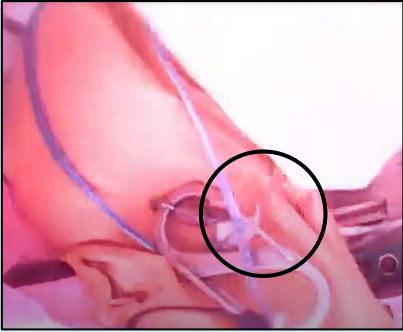
Major Launch Events		Images																			
5	Probe parachute released, but was unable to unfurl due to lack of container separation	Parachute Attached

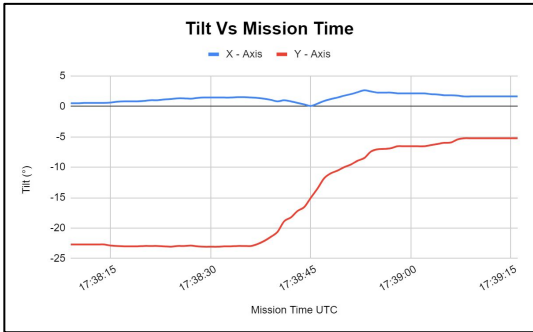
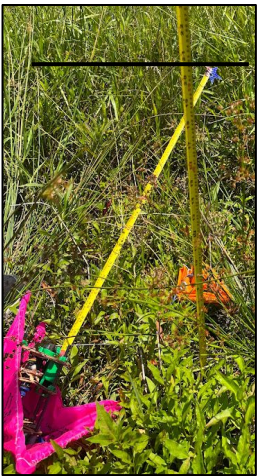
6	After hitting the ground at 11.2 m/s, the probe was forcefully ejected from the container, successfully uprighted, and raised our flag 540mm above the base of the probe	Tilt Vs Mission Time

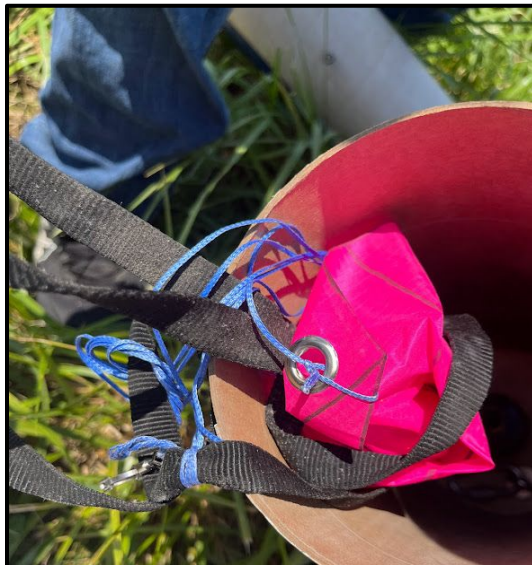
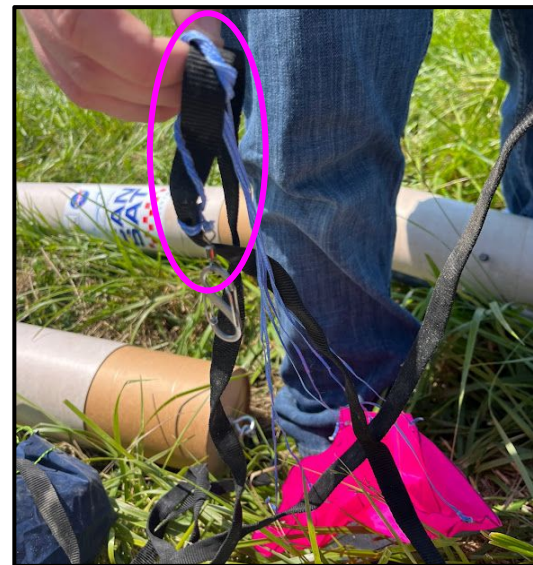
Failure Description	Failure/Root Cause	Corrective Actions
Container parachute became tangled with rocket shock cord	External interference from launch vehicle	<i>External interference from launch vehicle</i>
Heat shield deployment failure	Heat shield deployment obstructed by container after separation failure	<i>External interference from launch vehicle</i>

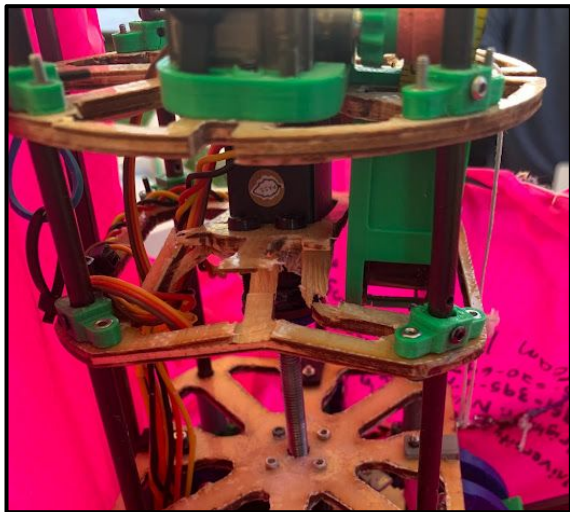
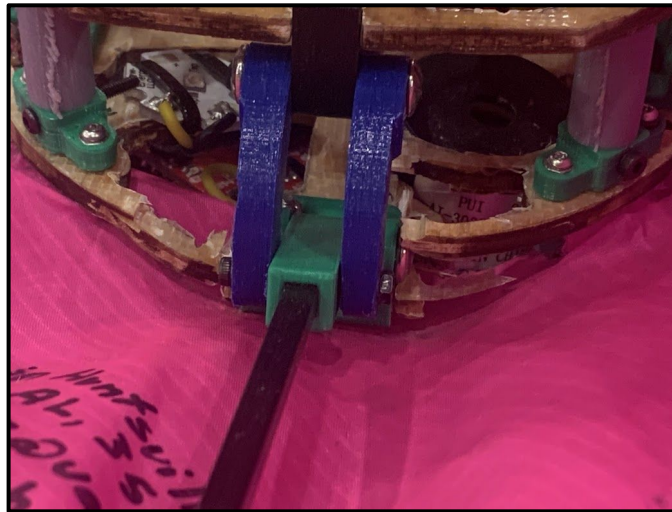
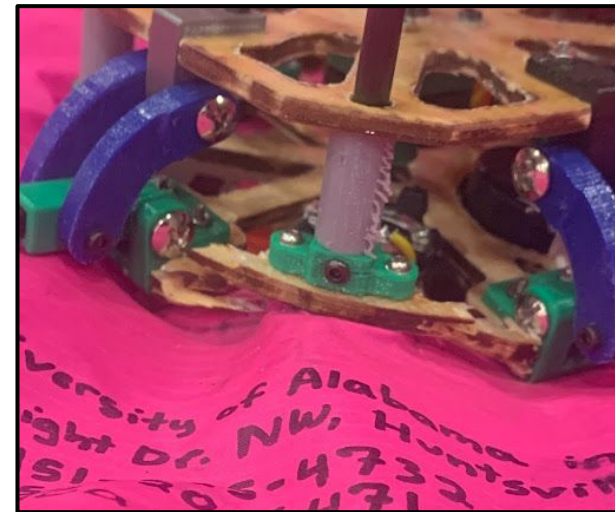
Failure Description	Failure/Root Cause	Corrective Actions
Several wood-fiberglass composite structural parts became warped/fractured	Probe and container fell at 11.2 m/s (6.2 m/s faster than expected)	<i>External interference from launch vehicle</i>
	Heatshield deployed while inside of container	<i>External interference from launch vehicle</i>

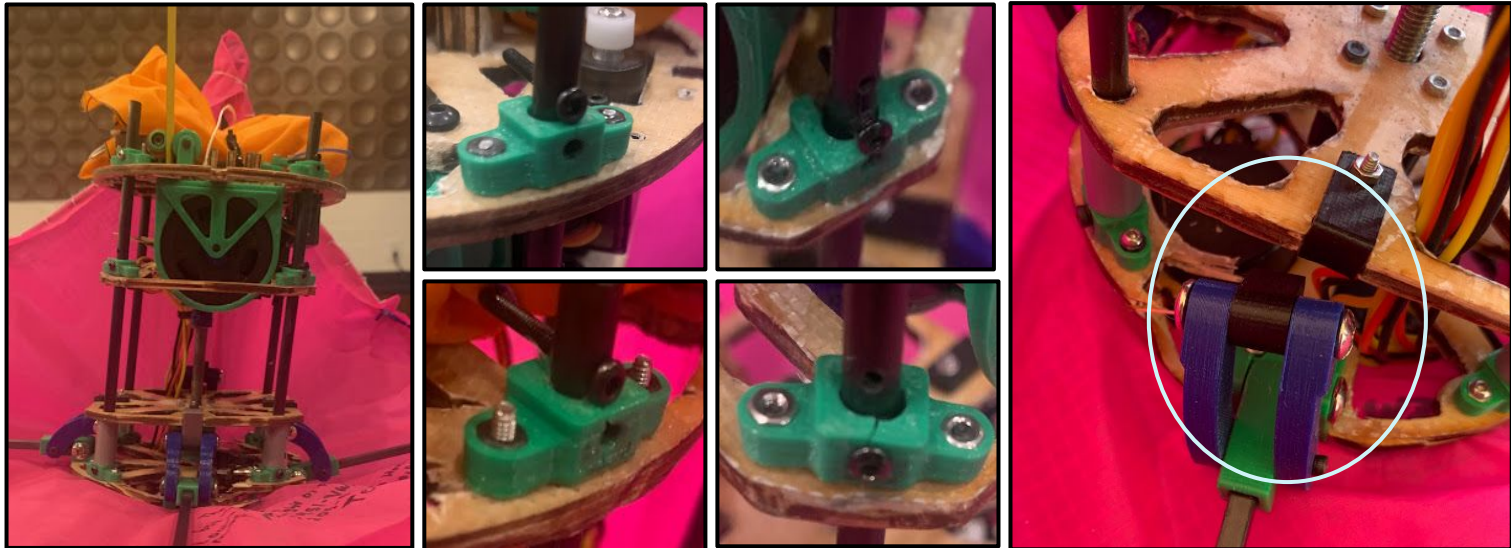
Failure Description	Failure/Root Cause	Corrective Actions
Main Structure Warped	3-D printed plate-rod mounts failed upon impact at 11.2 m/s (6.2m/s faster than expected)	Machine rod mounts or pursue stronger filament
3D printed heat shield deployment hinge broke	3D printed parts are too fragile to be structural components	Manufacture hinge arms out of wood-fiberglass composite

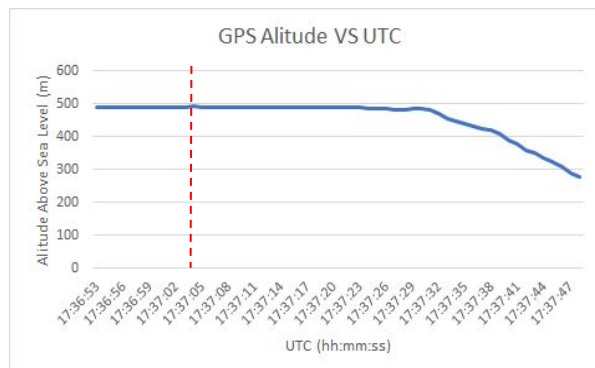
Failure Description	Failure/Root Cause	Corrective Actions
Momentary power loss upon impact with the ground	Large impact on probe electronics due to the probe falling at 11.2 m/s (6.2 m/s faster than expected)	<i>External interference from launch vehicle</i>
Probe camera did not record flight or landing	Momentary power loss caused the Adafruit Spy Camera to stop compiling video, which corrupted the video file	Source camera with live video storage to SD card
GPS Altitude incorrectly reporting	Insufficient testing of singular sensors lead to an inaccurate reading from the GPS altitude to be flown on flight day	Increase sensor testing, validation, and research
