CanSat 2023 Post Flight Review (PFR)

Team 1082 PWr Aerospace

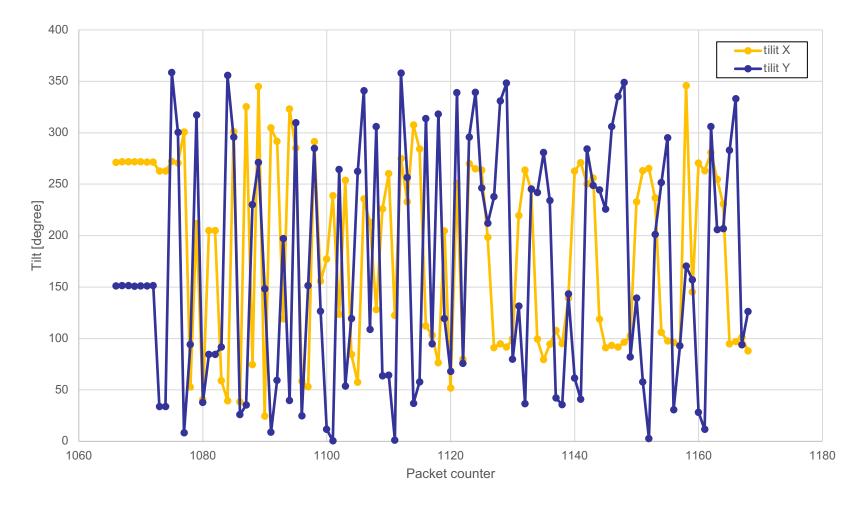
We noticed aliasing. Details will be provided in the following slide

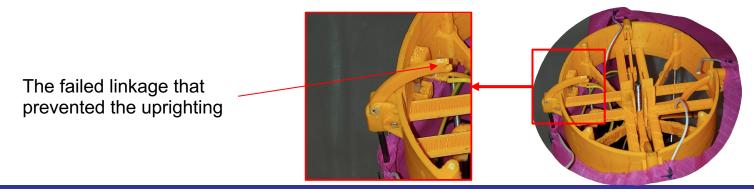
Failure	Root Cause	Corrective actions
Uprighting mechanism failed	Uprighting leg collapsed under the stress of the landing. Caused by the high latteral speed due to wind.	Proper materials used F.E. aluminium instead of 3D printed ASA. Higher safety margins for unexpected environmental factors.
Payload parachute descents speed was to low	No testing of the parachute descent speed was done before the launch.	The parachute should be tested with the proper weight before launch.
Some packets were lost	Not enough motor EMI shielding, probably hand-held radio (460MHz) second harmonic interference with XBee radio (915MHz). Line-of-sight was broken by the launchpad geometry	Changing one of the radios frequency. Better EMI management (shorter cables, shielding, keeping the distance)
