CanSat 2023

Post Flight Review Presentation

#1068

METUOR SPACE

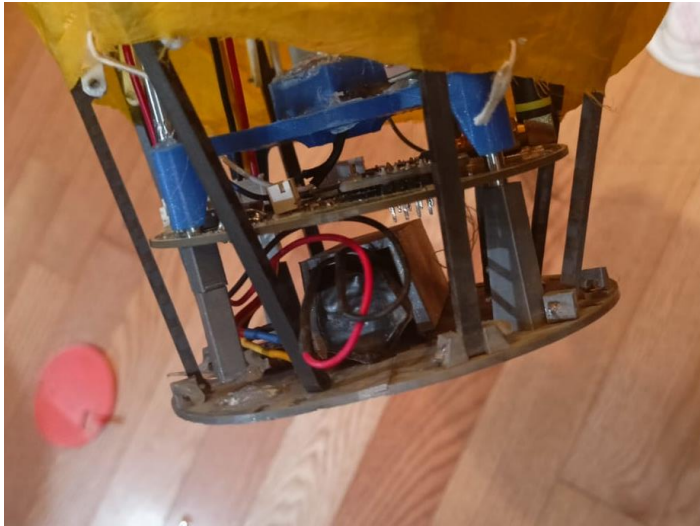
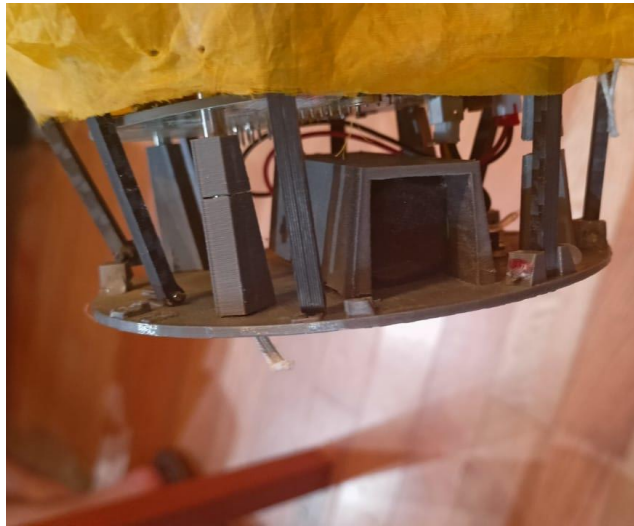
The baseplate was damaged and some of the arm hinges were broken during the crash.

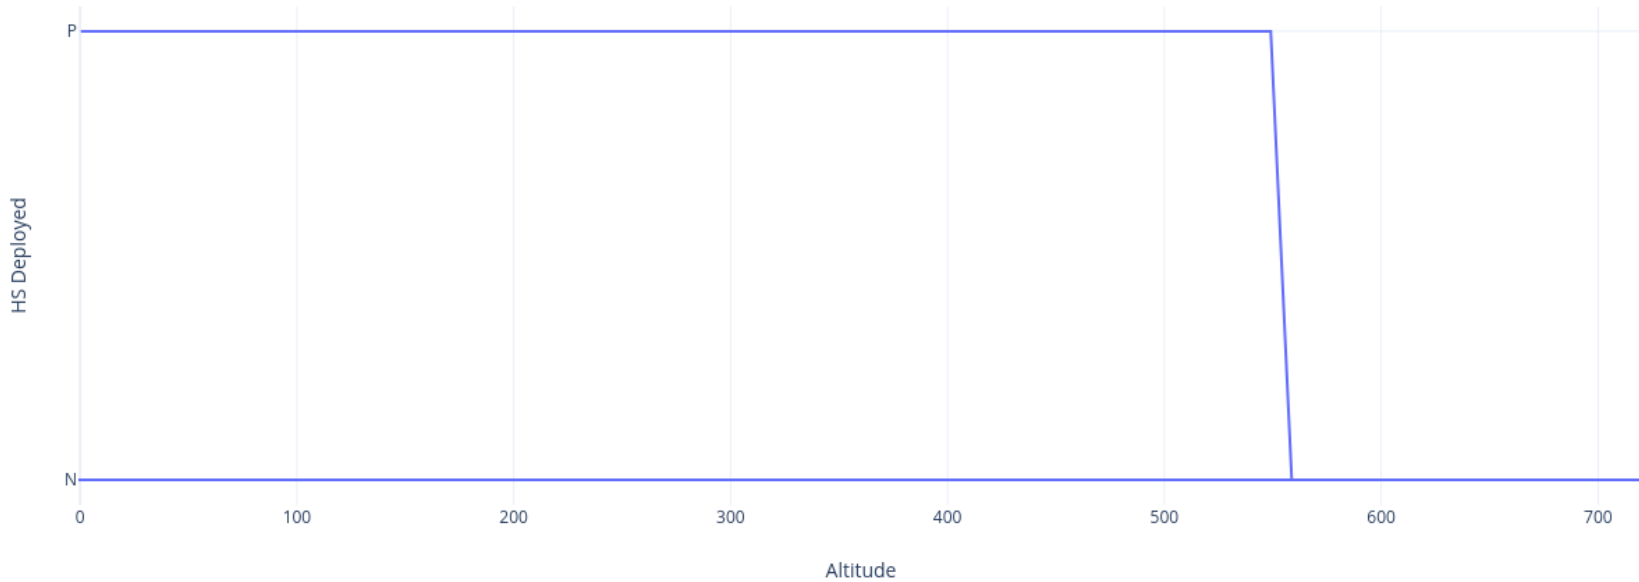
HS Deployed vs. Altitude

Heat Shield Deployed vs. Altitude

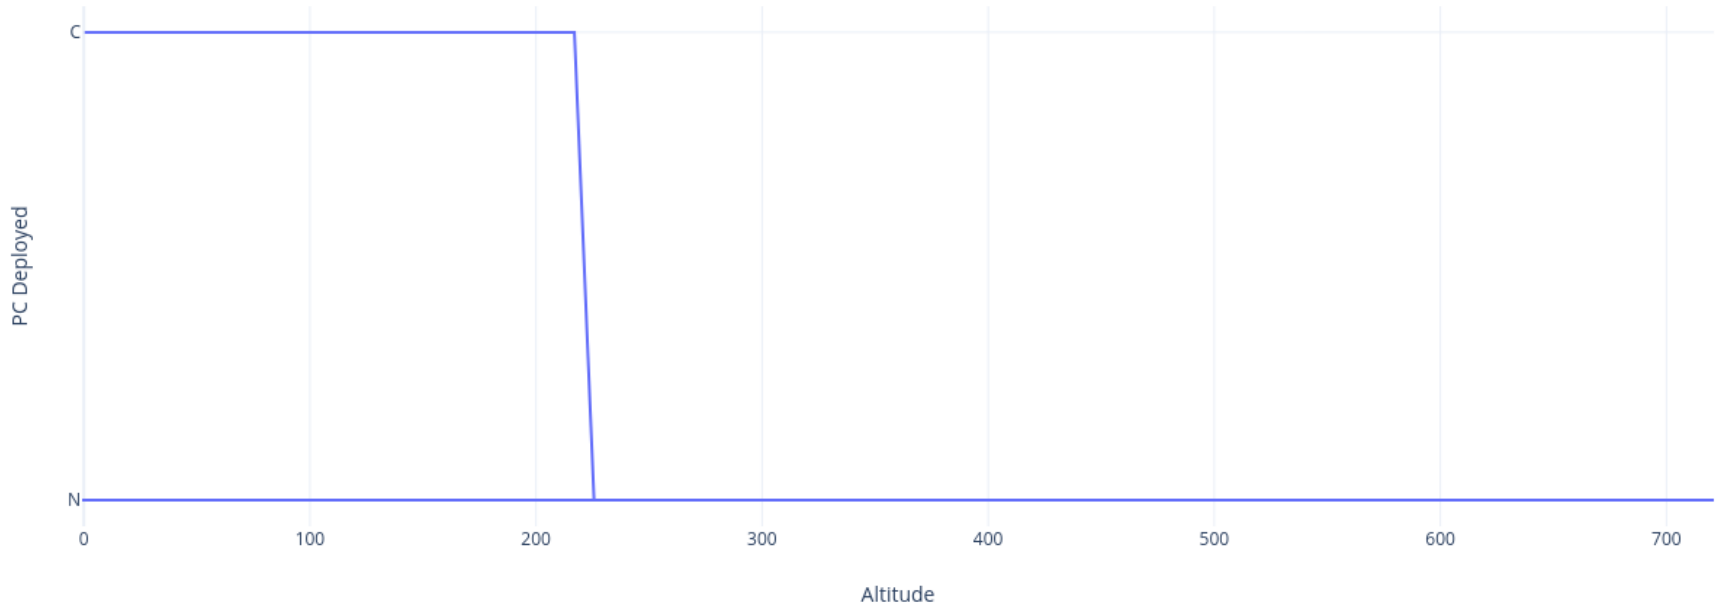
PC Deployed vs. Altitude

Payload Parachute Deployed vs. Altitude

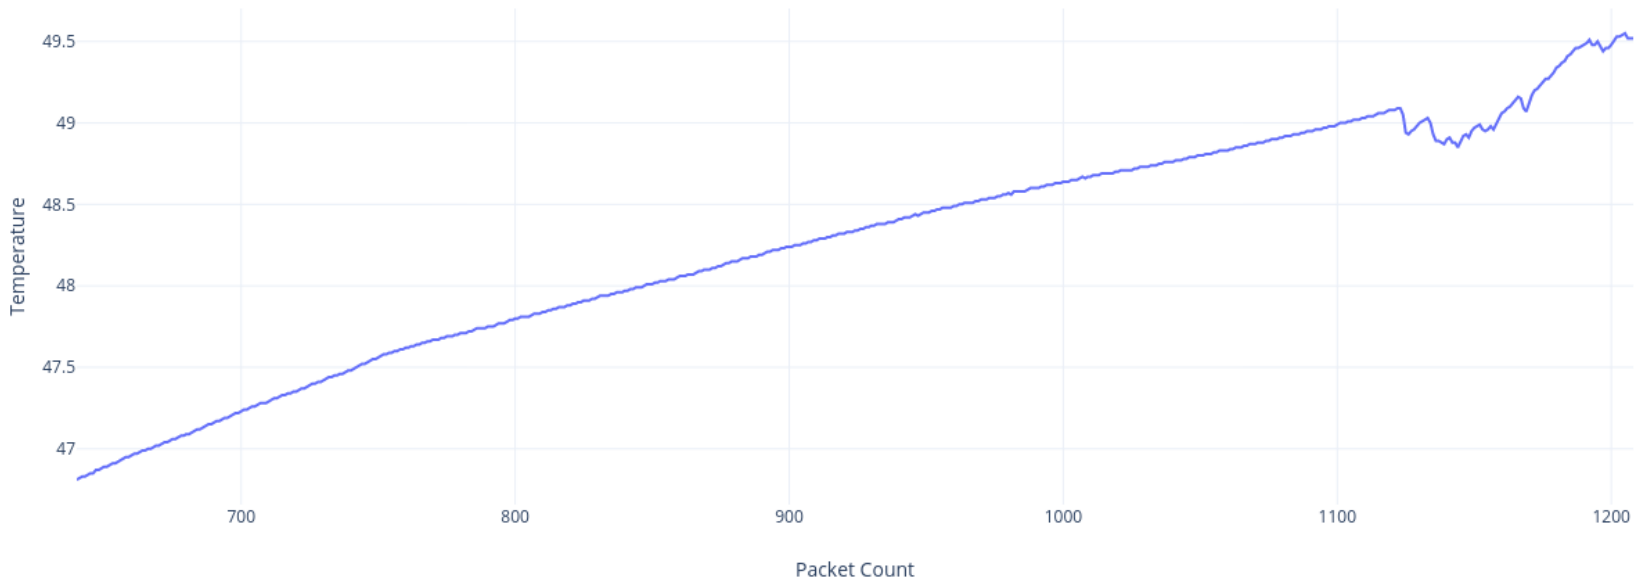
Payload Temperature vs. Packet Count

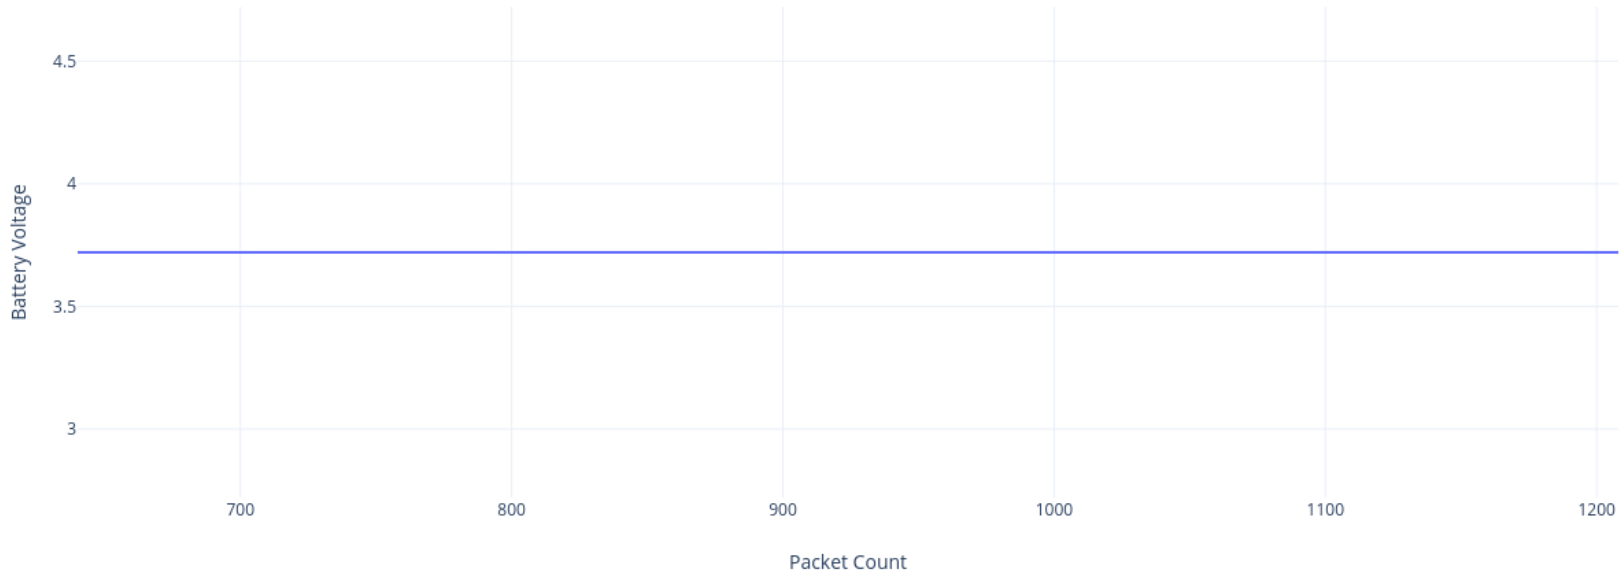
Payload Battery Voltage vs. Packet Count

Failure	Root Cause	Corrective Action
Rocket Separation Failure	The nose cone failed to separate from the rocket	External Factor – cannot be mitigated by the team
Battery Voltage Misreading	Programming Error	1 more line of code will be added, more stringent checks will be done
Payload Camera Failure	Power disconnection due to rocket failure	External Factor – cannot be mitigated by the team
Missing Telemetry After Landing	Landing behind a hill	An additional omnidirectional antenna at the GCS

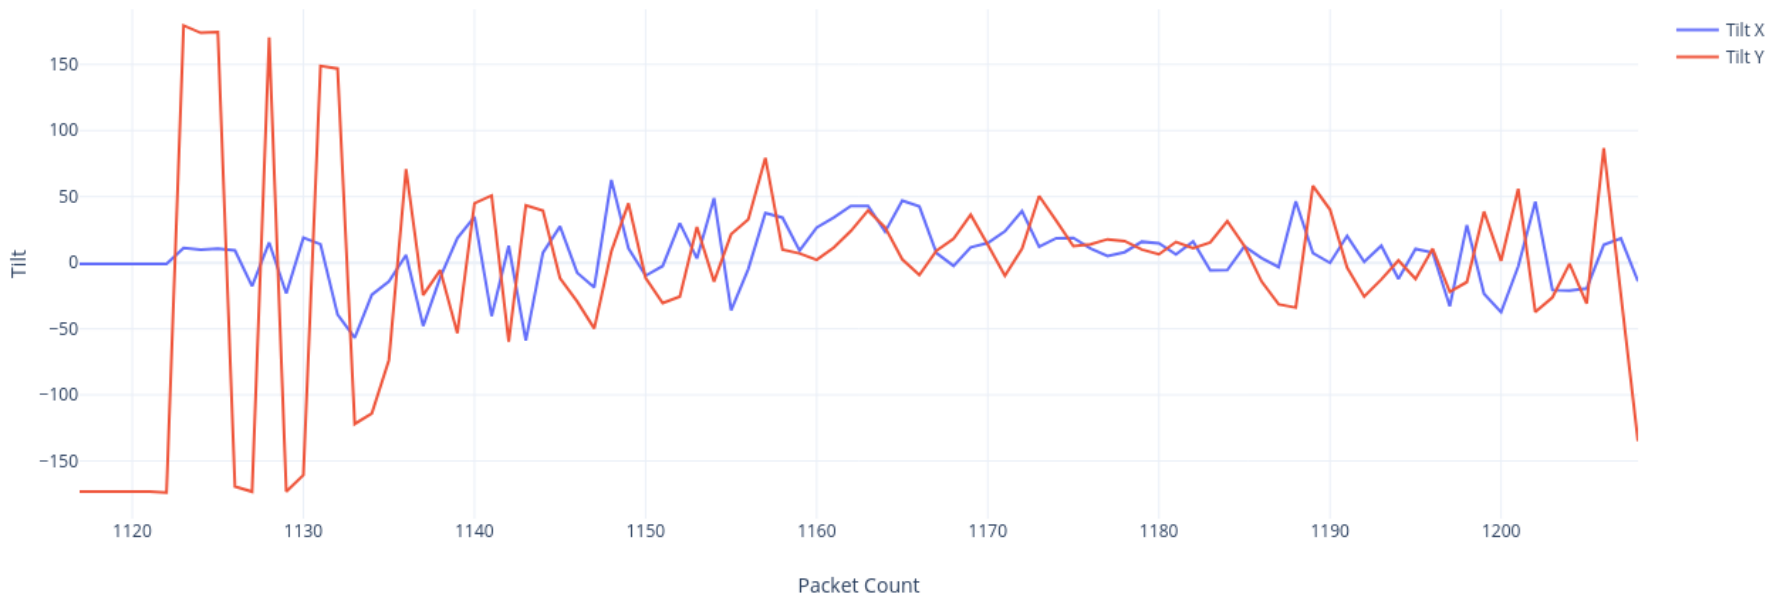
Tilt X,Y vs. Packet Count

Tilt Sensor vs. Packet Count

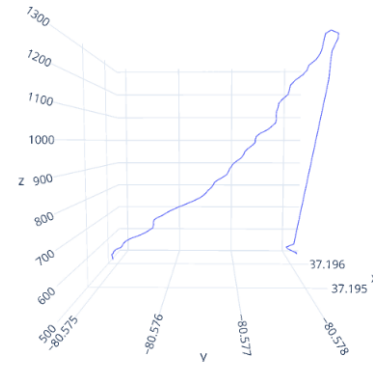
Payload GPS Position Plot
