# CanSat 2023

## Post Flight Review (PFR)

**1070**  
**Obsidian**

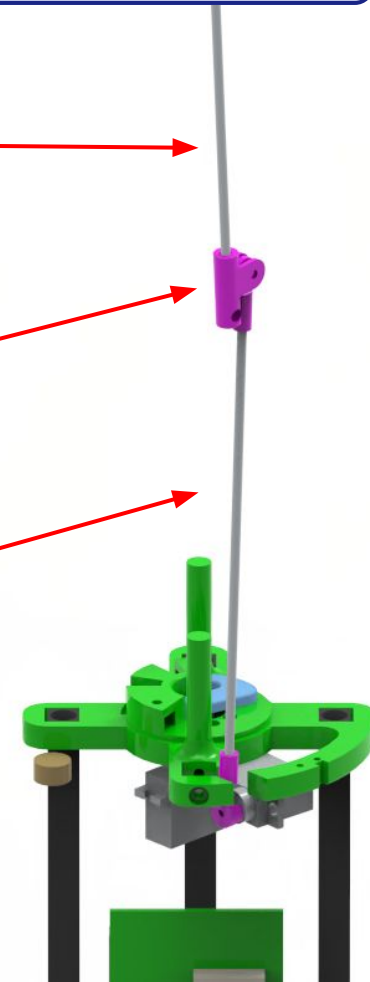
Broken Flagpole

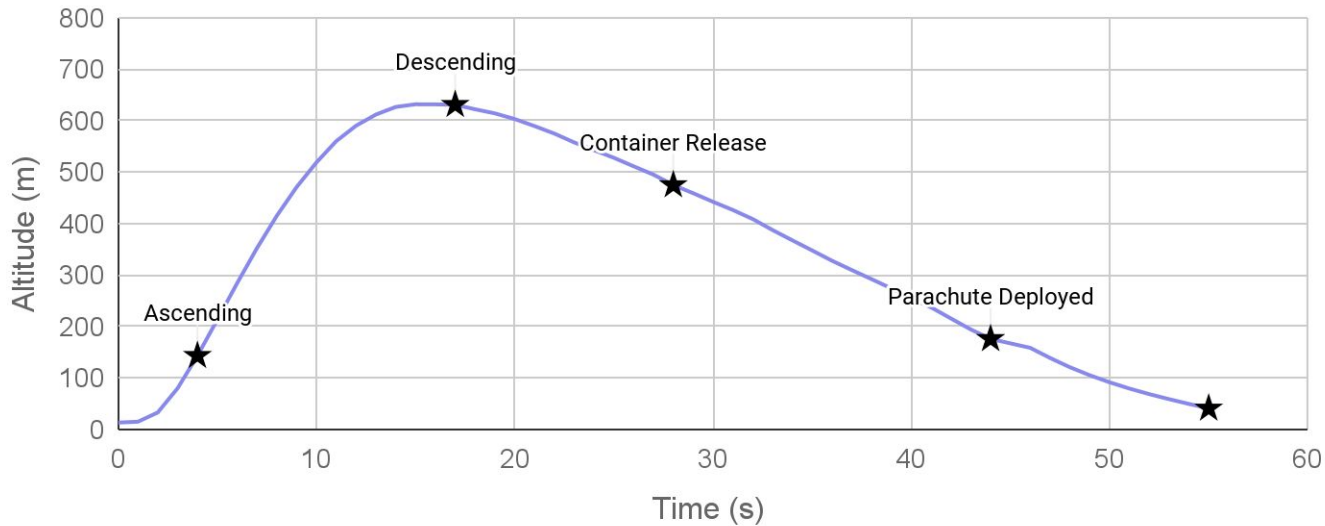
### Relative Altitude of Payload

Point of Interest	Value (m)
Ascending	79.6
Descending	631.8
Container Release	495.1
Parachute Deployed	194.0
Power Loss	40.4

The rocket did not reach the expected height of 670 - 725m. The apogee achieved was 632m.

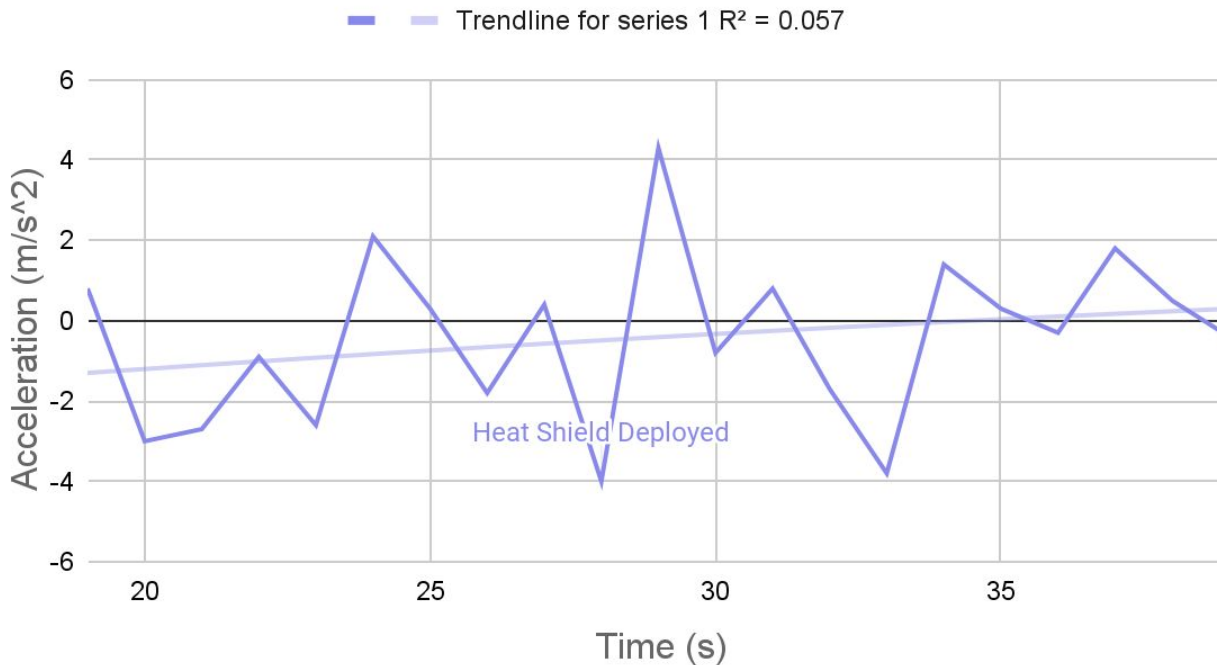
## Calculated Acceleration of Payload After Container Release

The combination of the payload releasing from the container and the heat shield deploying helped decelerate the CanSat from its downward fall.

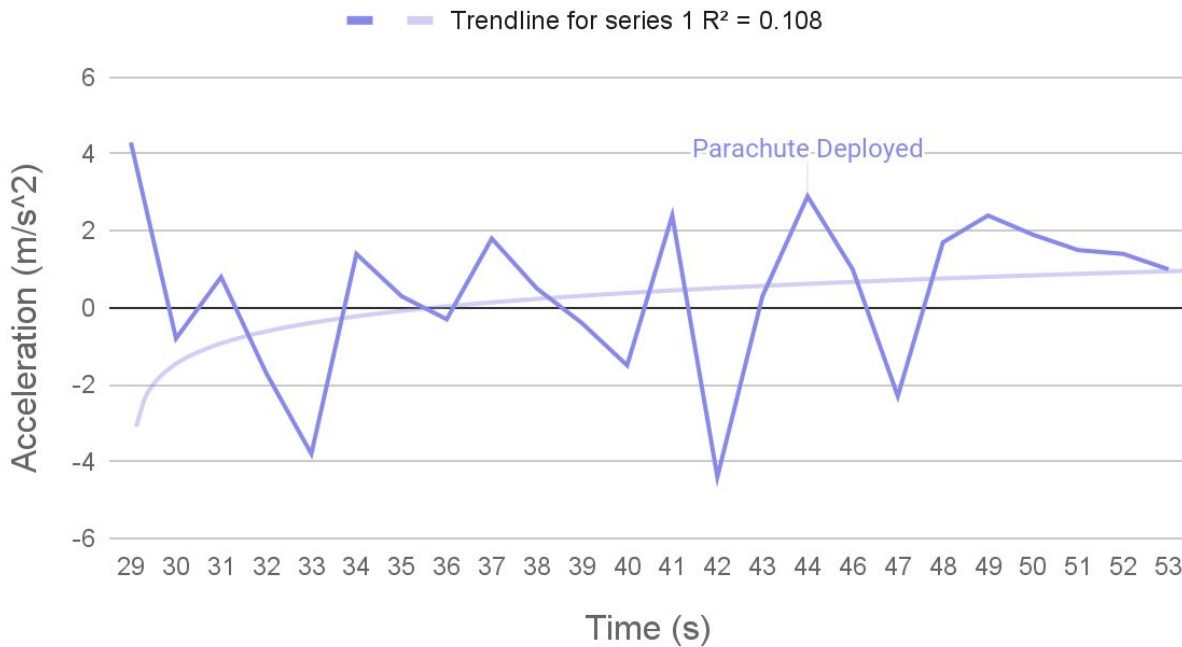
## Calculated Acceleration of Payload After Parachute Release

The parachute releasing did cause the payload to decelerate, but not as much as expected which should have been 5 m/s.

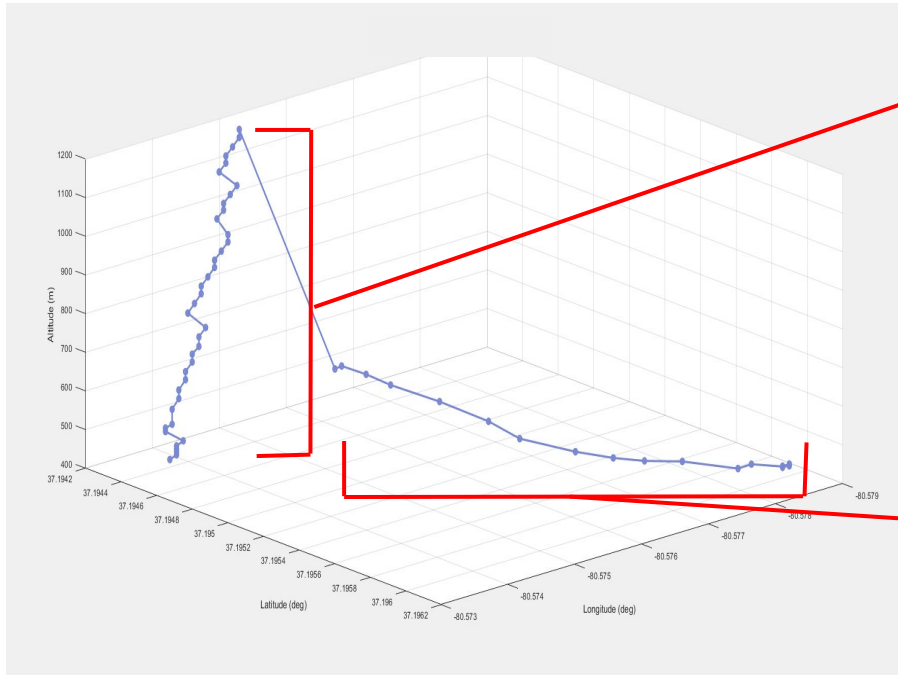
This is the descent of the Payload, which shows it drifting down to the ground

This is the GPS while the rocket was ascending

During the ascent, the SIV count dropped from 15 to 3, meaning that the GPS altitude data could not properly update until it was released from the rocket.
