CanSat 2023 Post Flight Review (PFR)

Team 1082 PWr Aerospace

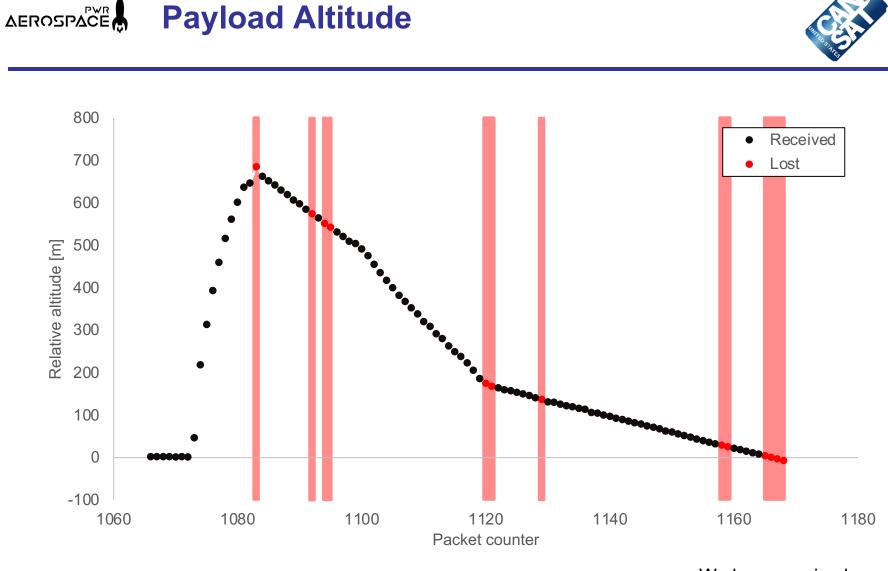
<u>Altitude was calculated using data from pressure sensor.</u> Further analysis will be performed using data from Payload sd card. We have received 90 out of 103 sent packets.
